The Recovery of a Dozer from a Highwall Using Blasting

**Tristan Worsey, Newmont Mining Corporation
&
Tyler Acorn, Newmont Mining Corporation**

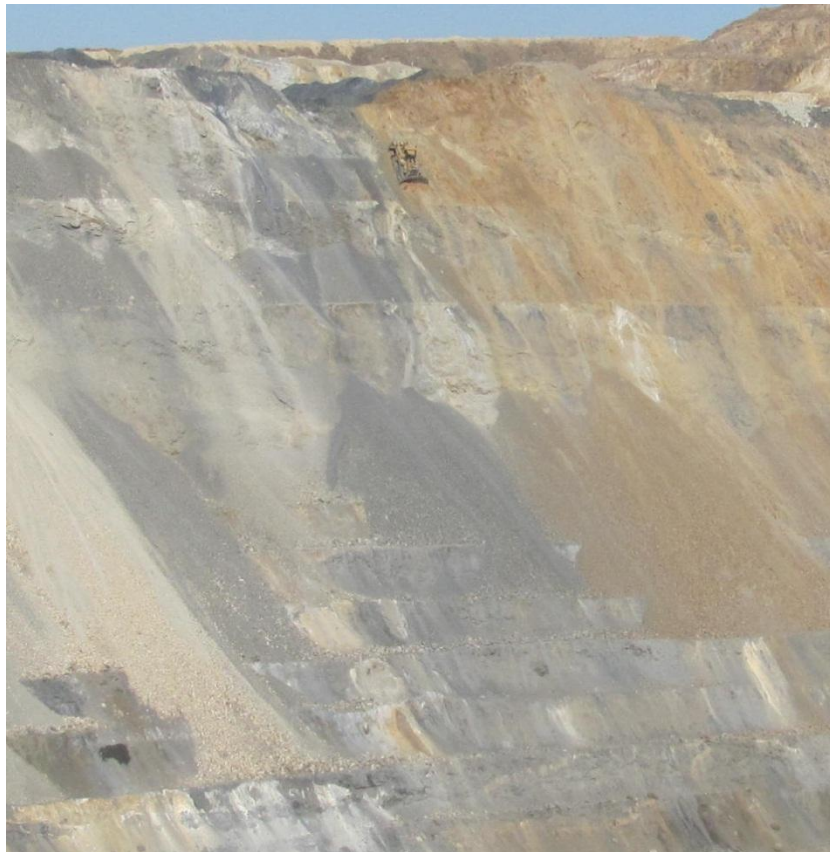
Figure 1. Day After the Dozer Drove off the Highwall

A dozer operator during night shift drove a D10 dozer up a berm and off the edge of the highwall. The dozer fell down the highwall 60 ft(18.3 m) before the front blade dug into a catch bench. The dozer operator high tailed it out of the dozer and climbed to safety after the dozer came to a stop on the catch bench. The highwall the dozer drove off was at a 65 degree angle but the dozer sat on the catch bench at a 40 degree angle. Figure 1 shows a photograph of the dozer caught on the catch bench.

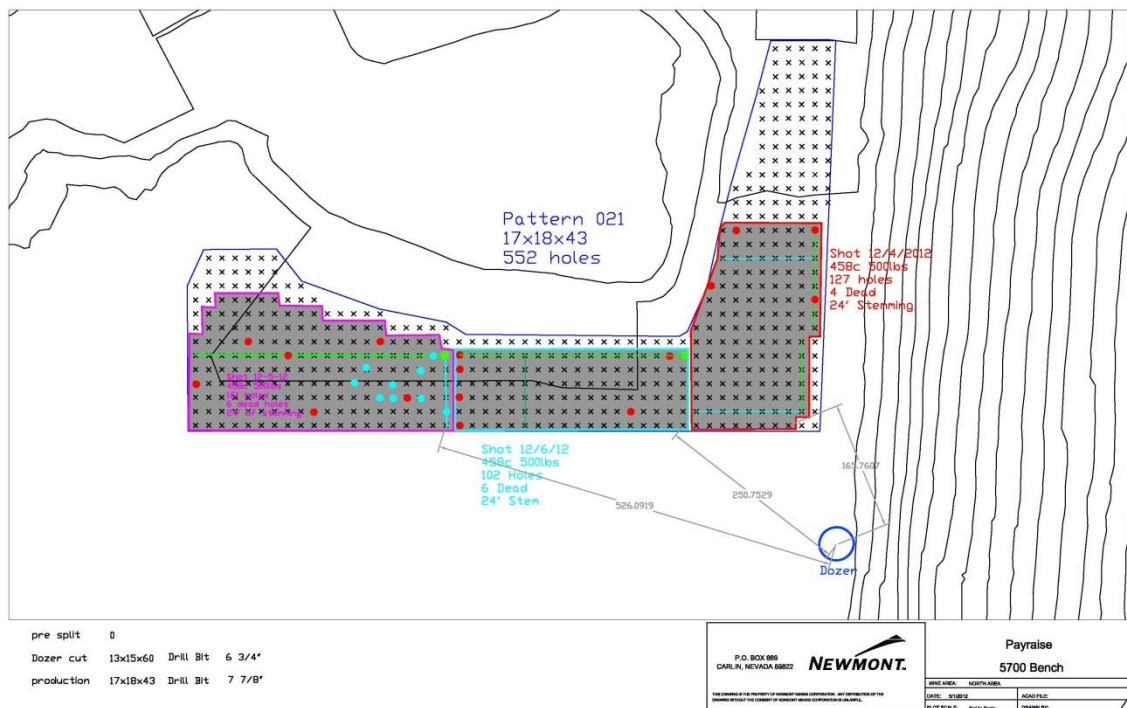
Figure 2. 5700 Bench Shot Map

The panel shots were limited to three rows to minimize constipation of the shot. After three rows, relief caused by the row timing and material moving, starts to decrease. This causes an increase in vibrations going back into the wall. The pattern designs of the drop cuts and panel shots are shown in Table 1. Figures 2 and 3 show a plane view of the pattern designs.

The first blast went well. Laser profile scans were taken before and after the blast and showed minimal movement. Figure 4 shows a picture of the blast. Notice the dozer in the lower right hand corner. The dozer was 166 ft (50.6 m) away from the blast. We did not decide to bring the next pattern back from the crest edge because the scans didn't show any movement in the material between the dozer and the blast. The blast had 127, 43-ft (13.1-m) holes, and 500 lbs (227 kg) of explosives per hole. The seismograph reading next to the dozer had a peak reading of 2.120 in/s (53.848 mm/s) at 26.9 Hz with the lowest frequency of 21.3 Hz at 1.840 ips (46.736 mm/s). It was noted that normal blasting practices did send quite a bit of material down the high wall. If this design was shot by the dozer it would have covered the dozer with material and potentially dislodged the dozer. See Figure 2. for the location of the blast on 12-4-2012. It is the blast bordered in red.

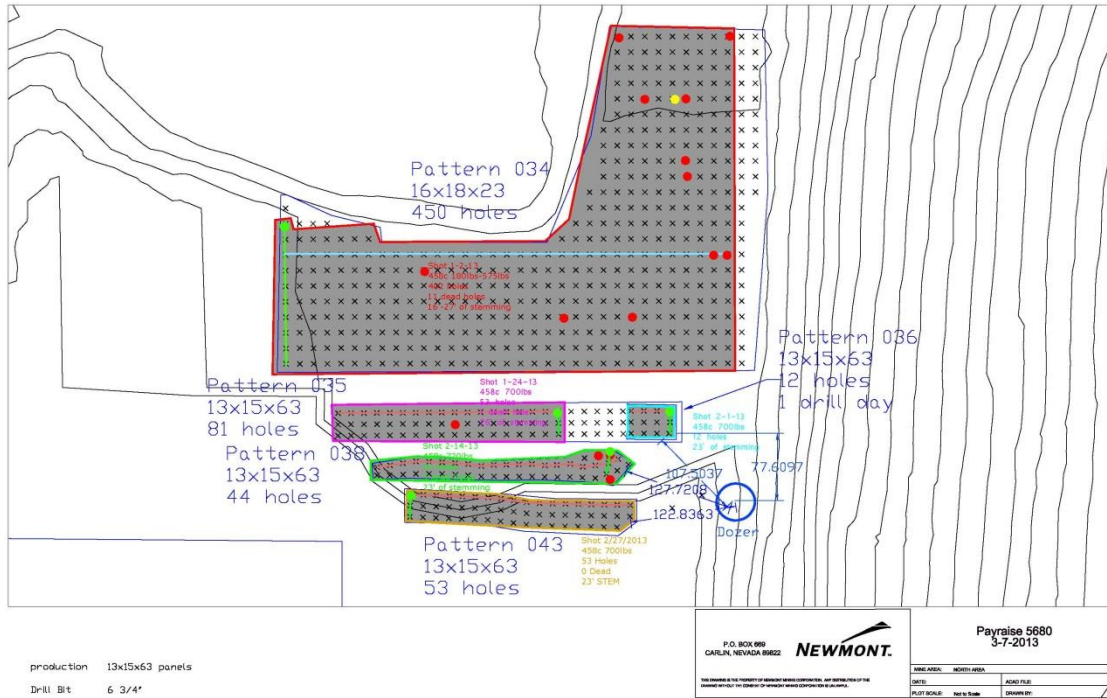
Figure 3. 5680 Shot Map

near or around the dozer. This blast (1-2-13) is outlined in red in Figure 3. This blast had less ground vibrations than the first shot that was similar in distance but this shot had less than half the lbs per delay. This blast had a lot of stemming ejection and was also quite violent as can be seen in Figure 7. Quite a bit of material was cascaded down the side of the highwall and there was some fly material that could have hit the dozer if it had been closer. There was a little bit of snow that fell down the high wall in front of the dozer but no actual material fell.

Shot number five next to the dozer was the first panel shot. There was a failure in the wall that split the pattern up into two shots. In Figure 3 there is a gap in-between the pink and teal shots that was the area that failed. The pink pattern (1-24-13) was the panel shot we shot first. The blast had 53, 63 ft (19 m) holes, and 700 lbs (318 kg) of explosives per hole. The closest hole to the dozer was 219 ft (67 m). This shot gave a PPV of 1.880 ips (47.752 mm/s) at 13.4 Hz which was the lowest frequency. The before and after dozer scans came back negative for significant movement. Figure 8 shows a picture of what the before and after scans looked like. All of the scans looked very similar except for one so only two scans will be shown in the paper. In the scan anything that is in blue is up to 1 ft (0.3 m) of material gain, gray is zero movement, and orange is up to 1 ft (0.3 m) of lost material. The green color means it went out of the range of -1 ft (-0.3 m) to 1 ft (0.3 m). The scan shows that the material near the dozer was basically unaffected. The material that is right next to the free face shows a little bit of loss but it was right in front of blast and it was expected to see a little bit of movement in front of the blast. One thing to note from this scan is that the material next to where the blast was located is unaffected. This means that this is a safe distance (140 ft/43 m) from the high wall to put the blast once we get to patterns directly behind the dozer. Figure 9 shows a photograph of the blast. This blast had the least amount of fly material and only one stemming ejection that was from a hole plugging during stemming.

Shot number six was the second panel shot next to the dozer. The blast had 12, 63 ft (19 m) holes (0 dead), and 700 lbs (318 kg) of explosives per hole. The teal pattern (2-1-13) in Figure 3 shows shot number six. This pattern was only 108 ft (33 m) away from the dozer and had more burden than designed due to the failure. This pattern also had some short holes in the middle of the pattern. This shot gave a PPV greater than 5 ips. Unfortunately the seismograph was set to a max of 5 ips so data was not received. The scan showed little to no movement on and around the dozer. This was a good sign that the dozer was pretty well set in the catch bench and as long as the material in the catch bench did

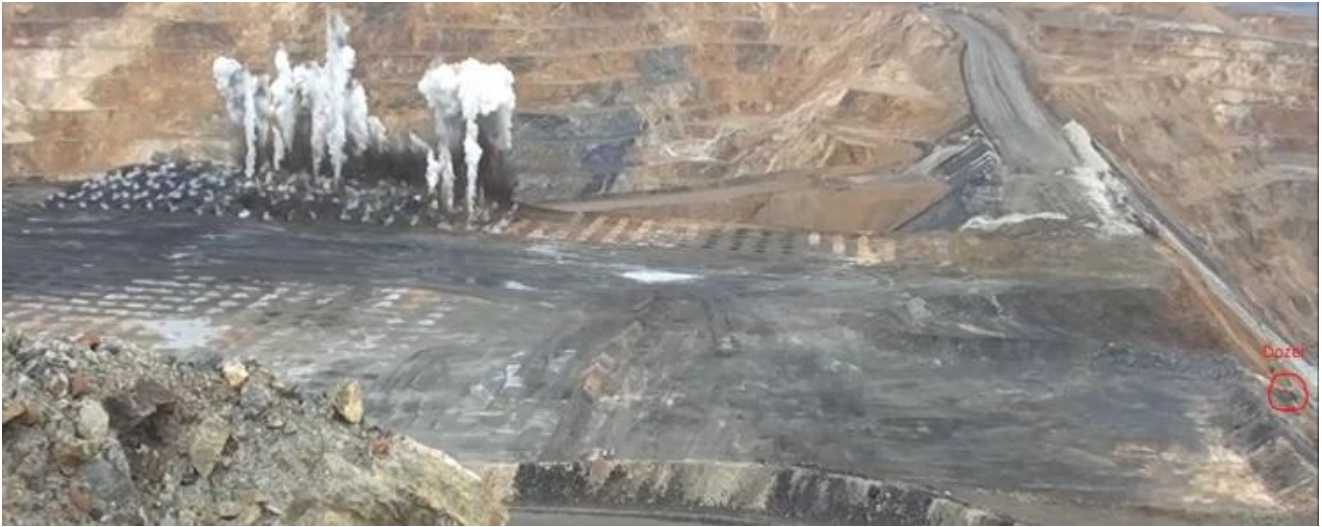
Figure 5. Second Dozer Shot

The next two blasts were on the same bench as the first with the same design and timing. These blasts are outlined in pink (12-5-2013) and teal (12-6-2012) in Figure 2. The second shot had 161 holes (8 dead) and was 529 ft (161 m) away from the dozer. This shot had a peak particle velocity of 0.210 ips (5.334 mm/s) at 9.3 Hz with the lowest frequency being 8.9 Hz at 0.180 ips (4.572 mm/s). Little to no movement was reported from the scans for the material around the dozer and the dozer itself. In Figure 5 the blast shows a little stemming ejection. This is very common when using detcord down the hole as an initiator. The stemming ejection causes quite a bit of fly material that is unwanted once we get closer to the dozer. The third shot had 102 holes (6 dead) and was 251 ft (77 m) away from the dozer. This shot had a PPV of 1.360 ips (34.544 mm/s) at 17.0 Hz with the lowest frequency being 10.2 Hz at 1.360

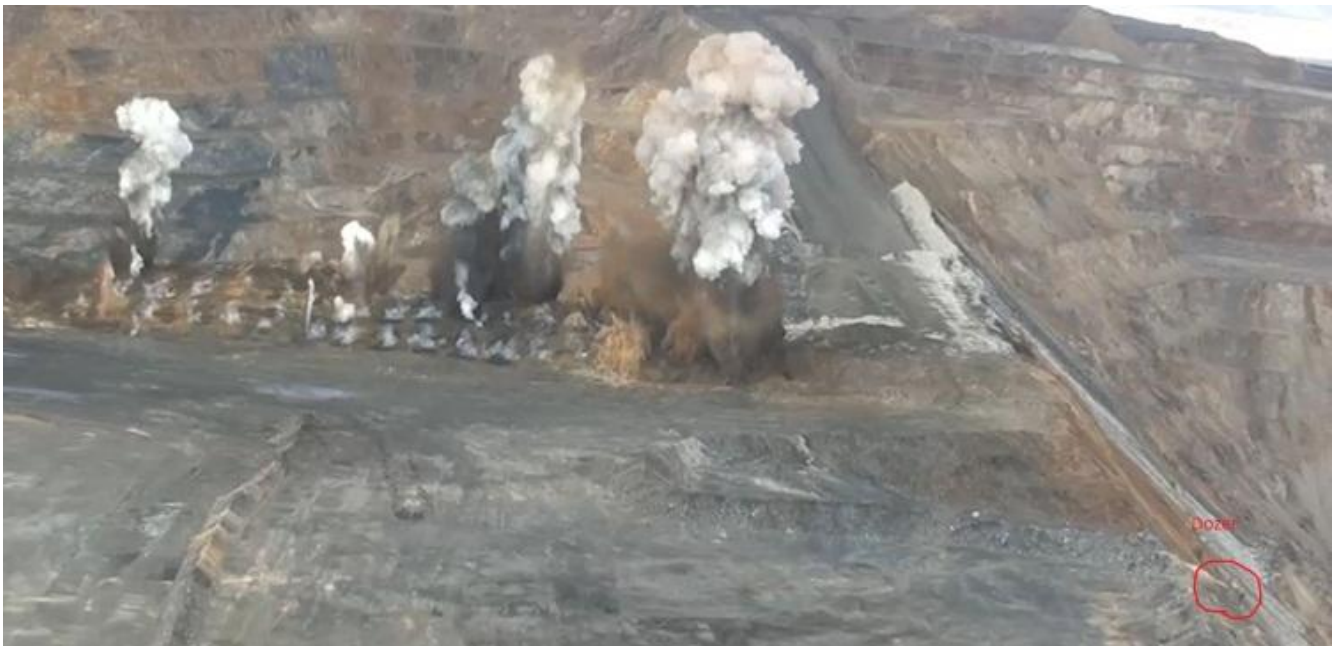
Figure 6. Third Dozer Shot

ips (34.544 mm/s). The scans reported little to no movement of the dozer from before the blast. In Figure 6 the blast shows a little more violent stemming ejection.

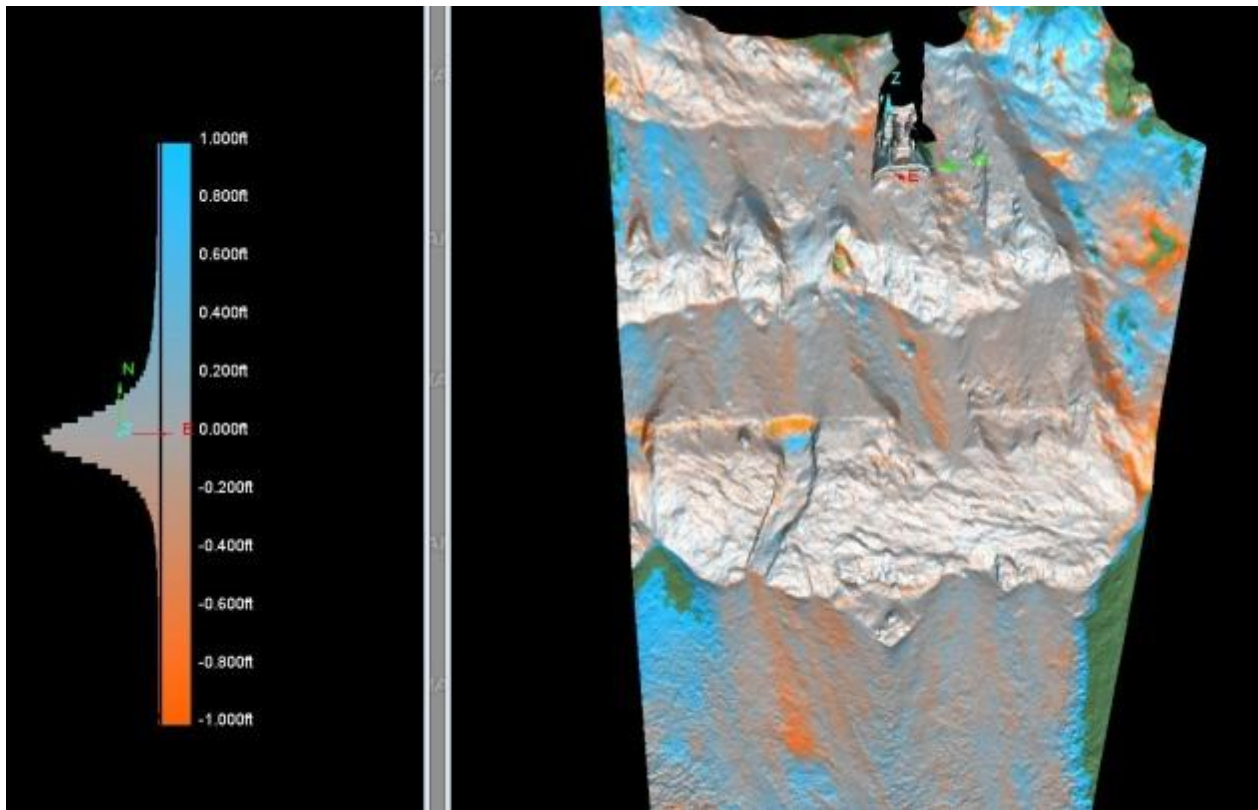
Figure 10. Dozer Scan of the Sixth Shot

not get casted the dozer would be fine. One thing from this blast that was noticed was the material in-between the dozer and the blast did show a little bit of movement, as seen in Figure 10 below. It was then decided to pull the rest of the panels 50 ft back. Figure 11 shows a photo of the shot. This shot had no fly material and no stemming ejection.

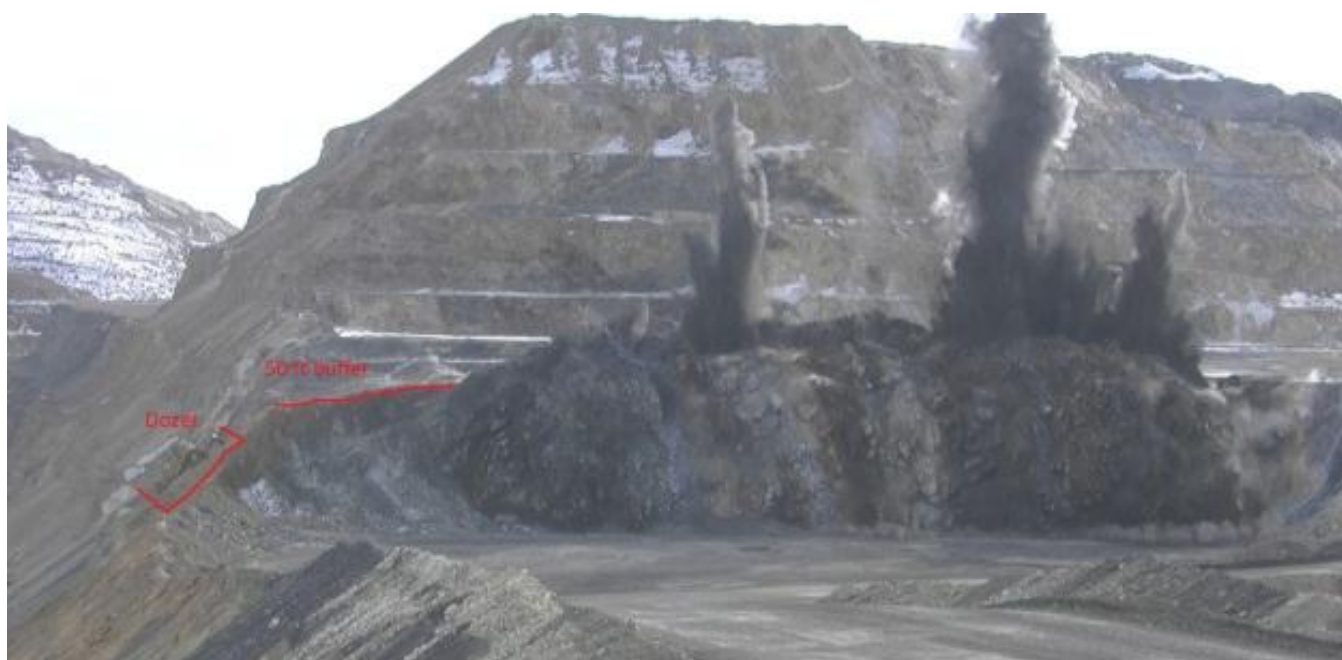
Figure 12. Eighth Dozer Shot

Shots 7 (2-14-13) and 8 (2-27-13) were similar in design to the first panel shot and can be seen in Figure 3 in green and yellow respectively. Shot 7 was 128 ft (39 m) away from the dozer. This blast was done while the blasting engineers were at the 2012 ISEE conference and the seismograph monitors were improperly set up and a valid reading was not obtained. The video was also missed, but the before and after dozer scans showed little to no movement of the dozer and the surrounding material. This shot was slightly north of being behind the dozer. Shot 8 was the last dozer shoot needed for equipment space to retrieve the dozer and was slightly south of being behind the dozer. This shot had 53, 63 ft (19 m) holes (0 dead), and 700 lbs (318 kg) of explosives. This shot gave a PPV of 8.80 ips (223.52 mm/s) at 28.4 Hz with the lowest frequency of 4.7 Hz at 6.00 ips (152.4 mm/s). The scans showed little to no movement of the dozer or the material around it. Figure 12 shows a photograph of the eighth dozer blast. This shot had some stemming ejection that was caused by using drill cuttings and holes plugging.

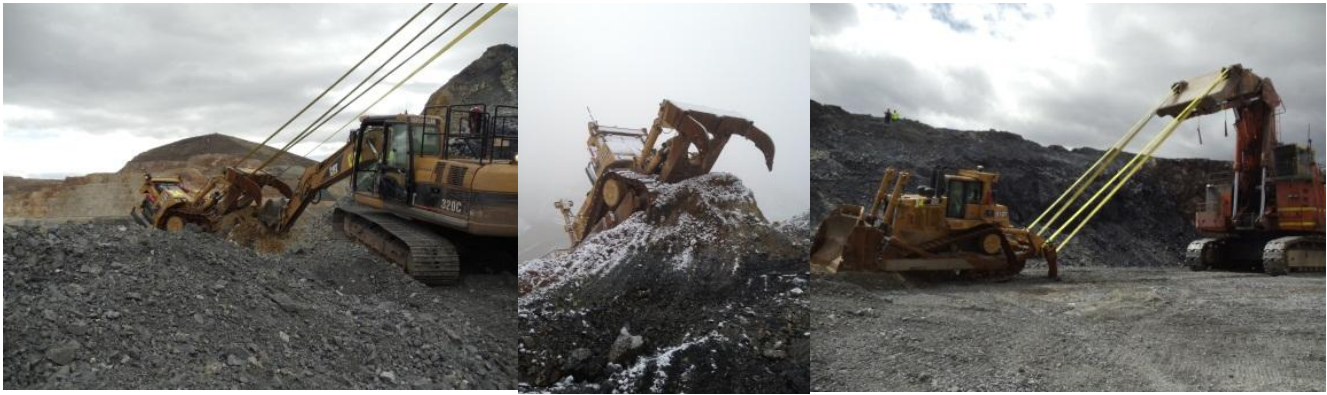
Figure 13. Dozer after Final Excavation

After the eighth shot the bench was down to the dozer blade elevation and there was enough room for equipment to operate. The 50 ft (15 m) buffer zone ended up being easy to dig. This was due to the shock wave from the blast creating micro fractures in the rock. This was expected, but was not expected to work as well as it did. Figure 13 shows the dozer after final excavation of the buffer zone. The removal of the dozer was done by strapping onto the tool bar with the shovel and digging the material out from under it with a backhoe then dragging it to more stable ground. The dozer had no blast damage and all of the glass was intact. Once the fluids were changed this dozer was out in the pit again working.
